Manhole Inspection Summary

Manhole # S33II1007MH

Location Address: **101 ST PAUL ST**

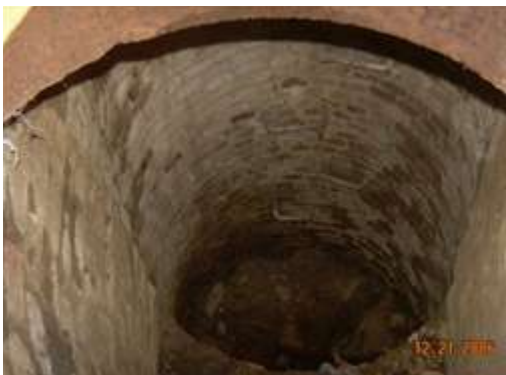
Defect

Infiltration: ☐ None ☒ **Joint** ☐ Cracks ☐ Mortar ☐ Roots ☒ **Wall**

Infiltration: ☐ None ☐ Joint ☐ Cracks ☒ **Mortar** ☐ Roots ☒ **Wall**

Adjustment and Barrel infiltration.

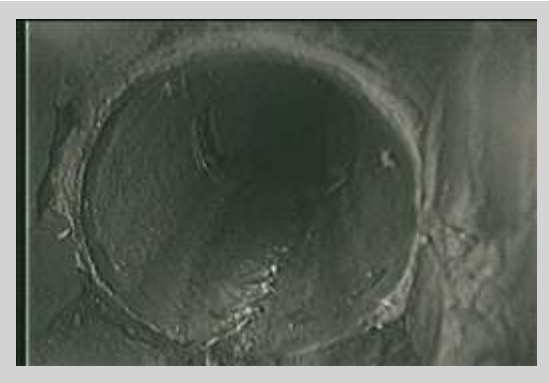
8 in. Circular Gravity Sewer
Pipe Out @ 12 O'Clock

Infiltration: **Evidence** Pipe Seal Cond: **Cracked**

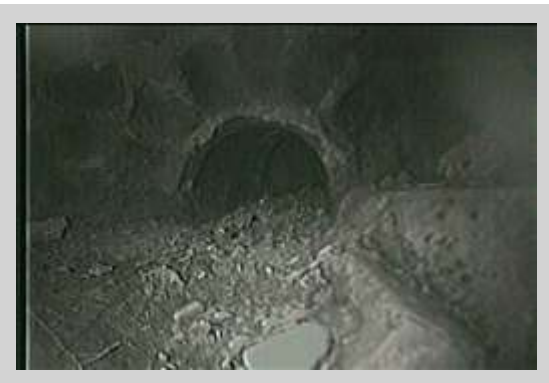
Pipe In @ 6 O'Clock

Deposits: ☐ None ☒ **Mud** ☐ Sludge ☒ **Debris** ☐ Grease

Silt Depth: **2** (in.) Deposits Extent: **Medium**

Infiltration: **Evidence** Pipe Seal Cond: **Unknown**

Connects To: **Stub connection / abandoned**
